# YOUR INSPECTION REPORT

Your Street

Saturday, July 11, 2026

RE: Report No. 3100, v.3  
Your Street  
Anytown, BC  
P0P 0P0

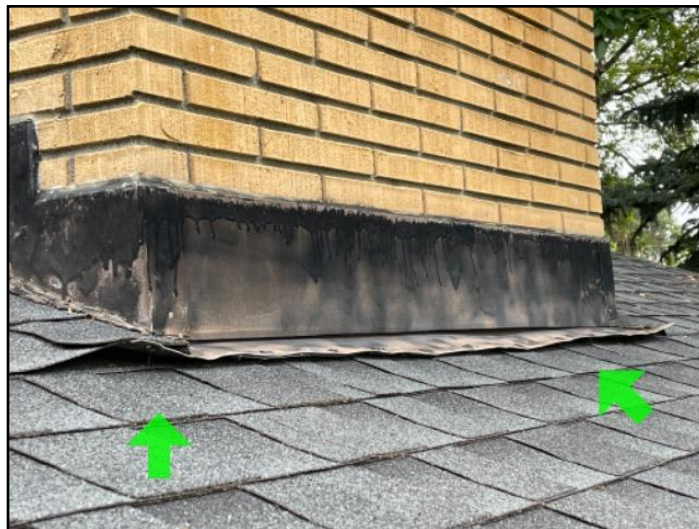
6.

**2. Condition:** • Chimney flashing loose or open seam

**Implication(s):** Loose flashing may allow water intrusion, leading to moisture damage and concealed roof leaks

**Task:** Have the chimney flashing repaired and properly secured by a qualified roofing contractor

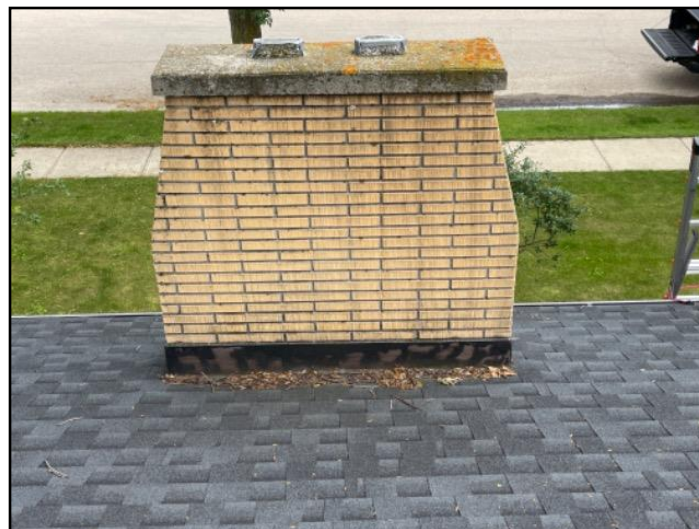
7.

**3. Condition:** • Cricket (roof saddle) missing at chimney

**Implication(s):** Water and debris may accumulate behind the chimney, increasing the risk of roof leaks and roof deterioration

**Task:** Recommend installation of a properly flashed cricket by a qualified roofing contractor

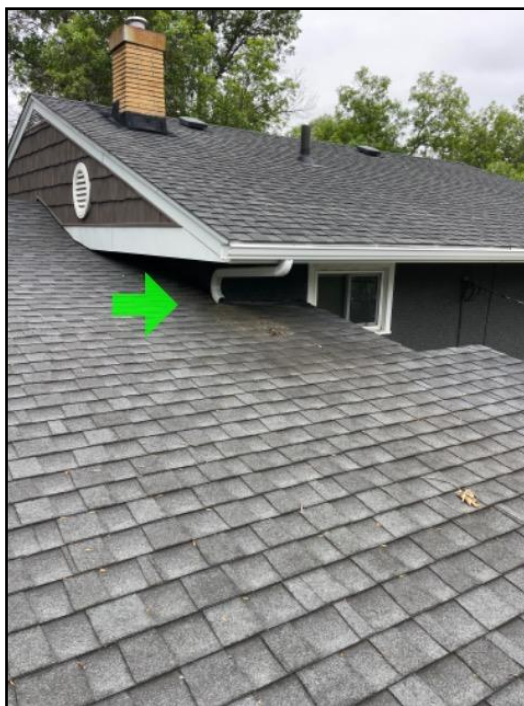
11.

**5. Condition:** • Downspouts discharge onto lower roof surfaces

**Implication(s):** Concentrated water discharge may cause premature roof wear and increase the risk of leaks

**Task:** Recommend extending or redirecting downspouts to an approved drainage location

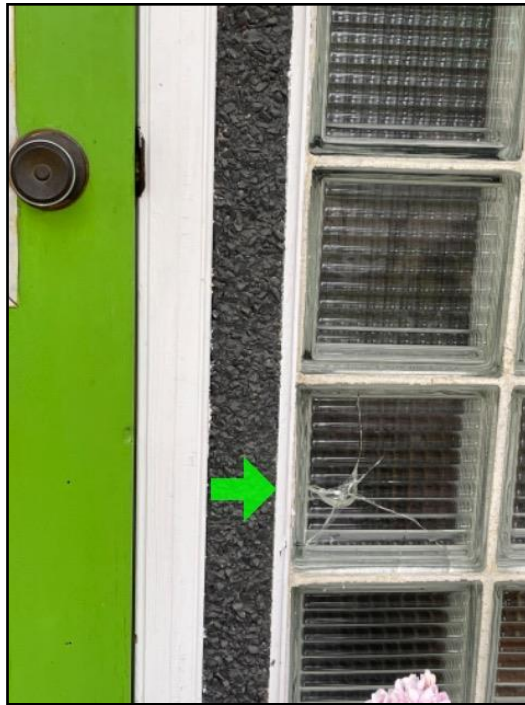
12.

**7. Condition:** • Broken window glazing was observed

**Implication(s):** Broken glazing may allow air and water infiltration, reduce energy efficiency, and present a safety hazard

**Task:** Recommend replacement of the damaged glazing

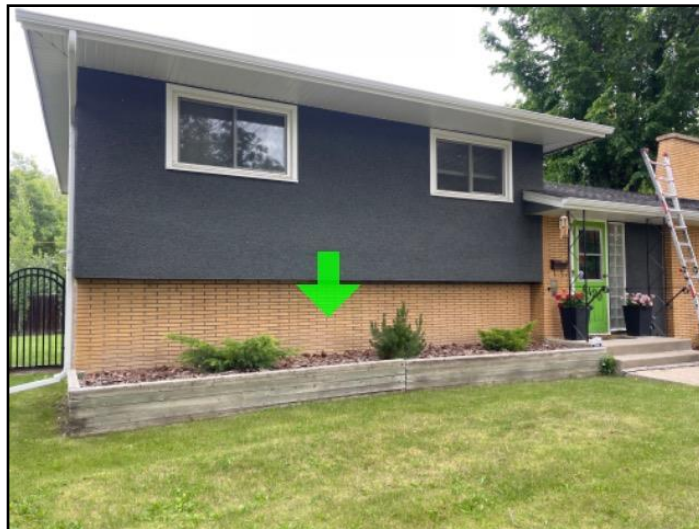
17.

**9. Condition:** • Planters and gardens in contact with exterior wall

**Implication(s):** May retain moisture against the wall, increasing the risk of deterioration and potential moisture intrusion

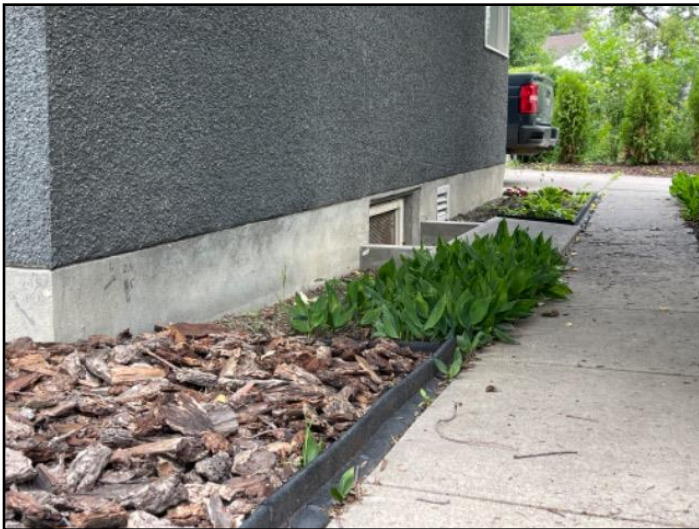
18.

**10. Condition:** • Negative or inadequate slope observed around foundation walls

**Implication(s):** Increased risk of surface water accumulation, basement/crawlspace moisture intrusion, foundation deterioration, and potential long-term structural damage.

**Task:** Regrade the surrounding soil and/or improve drainage provisions to promote positive drainage away from the foundation.

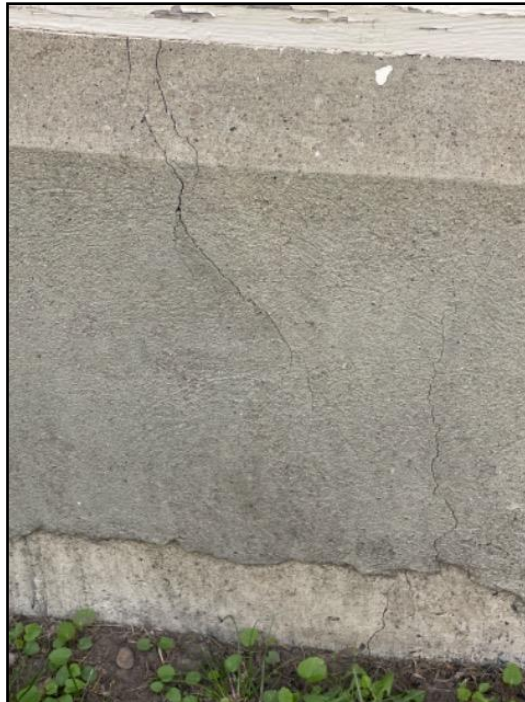
21.

**12. Condition:** • Typical foundation shrinkage cracks were observed in the foundation wall

**Implication(s):** Unsealed cracks may allow water and moisture intrusion, which can contribute to dampness and deterioration of building materials over time.

**Location:** Foundation Wall - West Side

**Task:** Recommend sealing the cracks with an appropriate foundation crack sealant to help reduce moisture penetration.

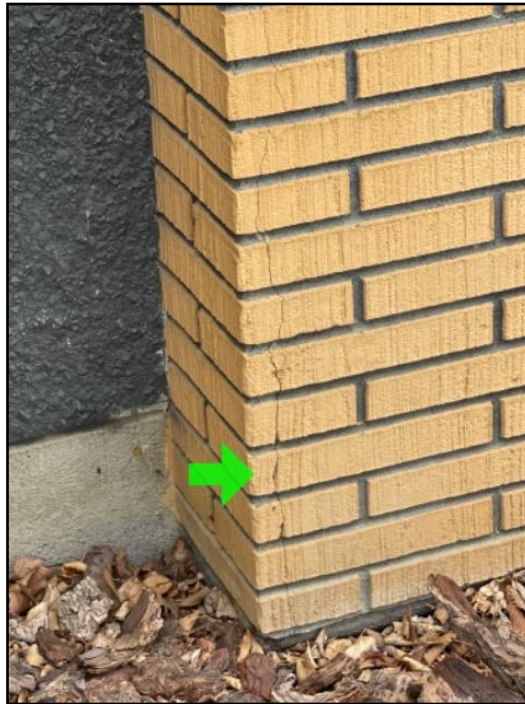
22.

**13. Condition:** • Typical minor cracking observed in the masonry veneer wall

**Implication(s):** Minor cracks may result from normal movement but should be monitored for changes

**Task:** Monitor for changes and seal/repair as needed to help prevent moisture intrusion

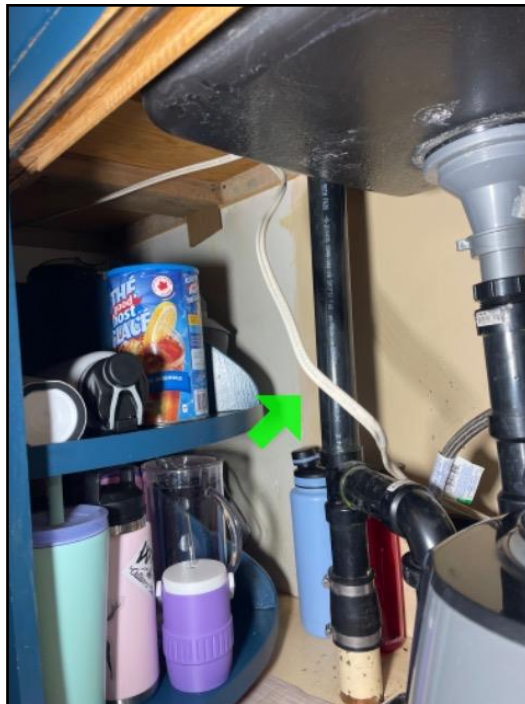
26.

**15. Condition:** • Electrical wiring not properly secured

**Implication(s):** Loose wiring may result in damage, increased wear, or potential electrical hazards

**Task:** Have wiring properly secured by a qualified electrician

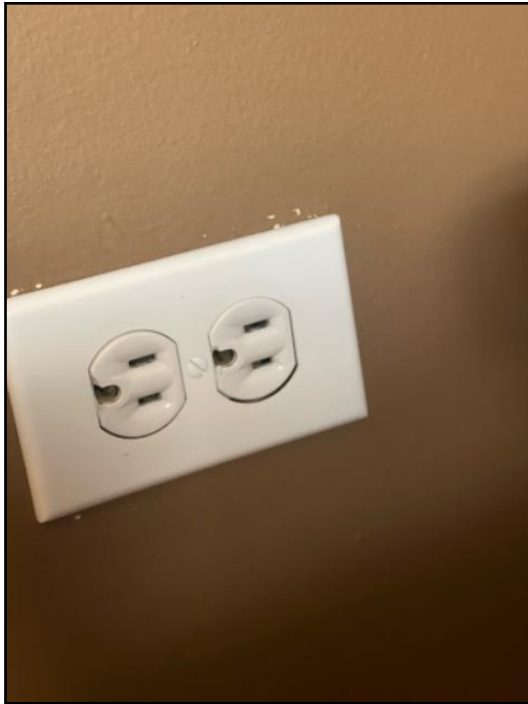
27.

**17. Condition:** • Damaged electrical outlet observed.

**Implication(s):** Damage may affect safe operation of the outlet and could present a potential safety hazard if left

**Task:** Repair or replace the outlet as needed

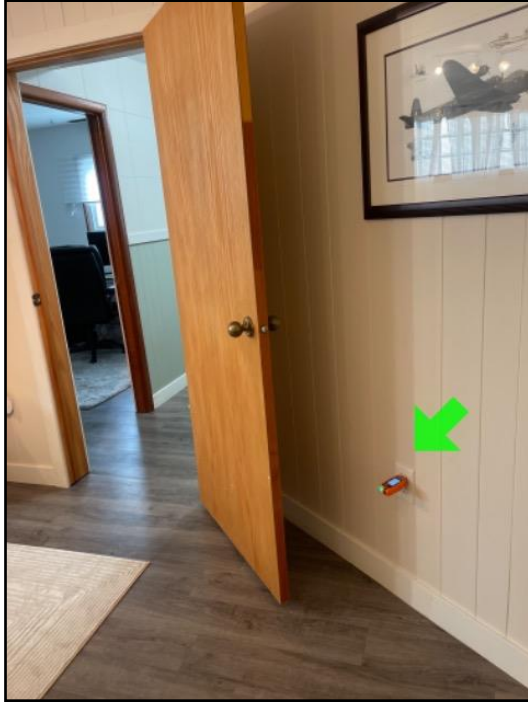
30.

**18. Condition:** • Loose electrical outlet observed

**Implication(s):** May affect connection stability and increase risk of arcing or damage and electric shock

**Task:** Secure or replace receptacle as needed

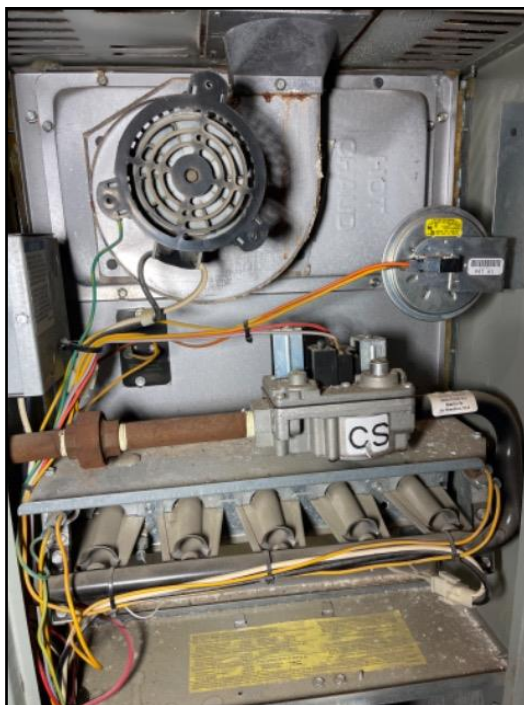
37.

**22. Condition:** • Furnace appears to be near the end of its expected service life

**Implication(s):** As the furnace approaches end of life, there is an increased risk of breakdown, reduced efficiency, and potential loss of heat if failure occurs.

**Task:** Regular HVAC servicing and maintenance is recommended to maximize furnace life and reliability

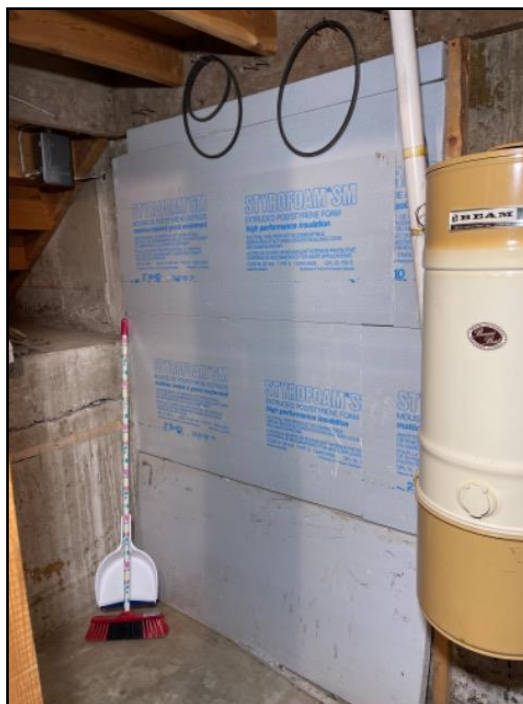
38.

**25. Condition:** • Exposed foam board insulation observed

**Implication(s):** Exposed foam board insulation may present a fire hazard and can release toxic smoke when burned

**Task:** Recommend installation of an approved protective barrier

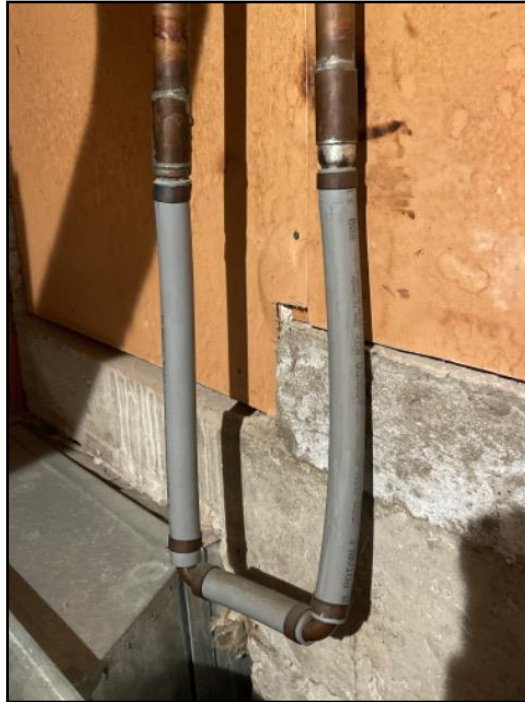
41.

**26. Condition:** • Polybutylene (Poly-B) water supply piping was observed

**Implication(s):** Poly-B piping has a history of premature failure and leaks, which may result in water damage. Some insurance providers may have coverage restrictions or requirements related to Poly-B plumbing

**Task:** Recommend evaluation by a licensed plumber to assess the condition of the Poly-B plumbing system and determine if any monitoring, repairs, or replacement are required.

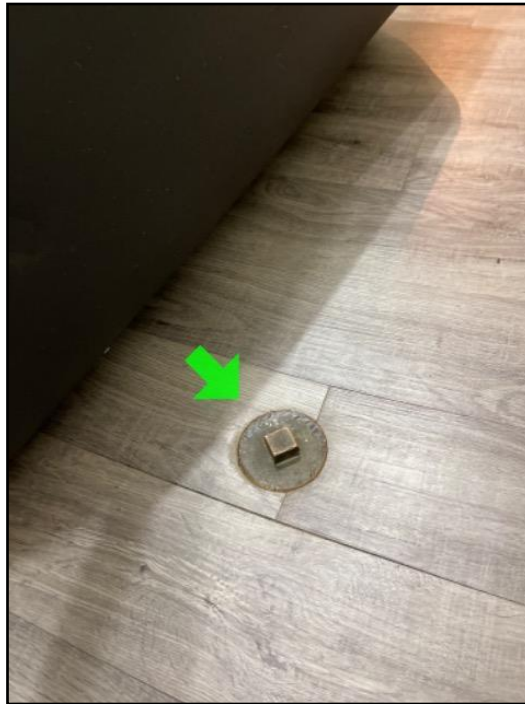
42.

**28. Condition:** • Perforated floor drain grate missing

**Implication(s):** Missing floor drain grate may allow debris to enter the drain, increasing the risk of blockage and creating a potential trip or safety hazard

**Task:** Install appropriate grate cover

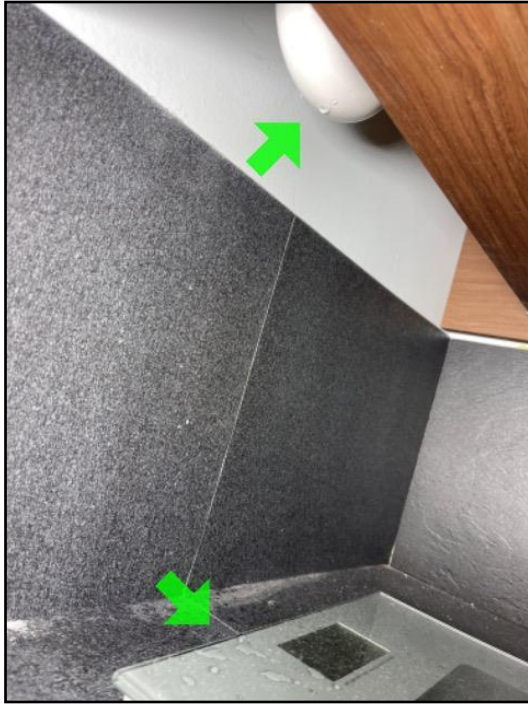
43.

**29. Condition:** • Sink waste piping leaking

**Implication(s):** May cause moisture damage, deterioration of cabinetry, and potential mould growth

**Task:** Repair or replace affected drain piping and connections

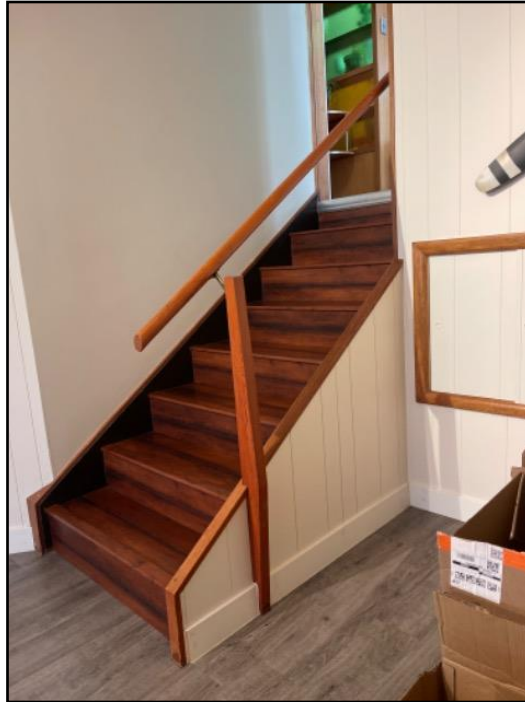
46.

**31. Condition:** • Stair guard rail missing

**Implication(s):** Missing guardrail increases the risk of falls and injury

**Task:** Install a compliant guardrail by a qualified contractor

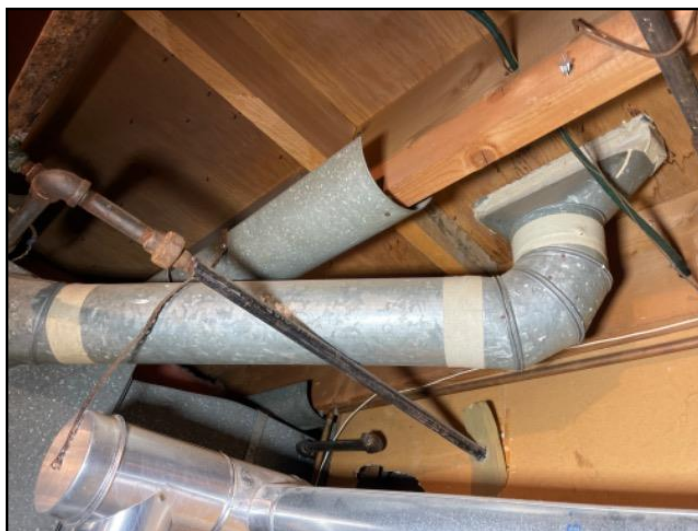
47.

**35. Condition:** • Building materials observed may be consistent with age and construction methods that could include asbestos-containing materials.

**Implication(s):** If asbestos-containing materials are present and disturbed, they may release hazardous fibres, posing a potential health risk to occupants and workers

**Task:** Recommend further evaluation and testing by a qualified environmental professional prior to any disturbance, renovation, or removal of suspect materials.
