# YOUR INSPECTION REPORT

Your Street

Saturday, July 11, 2026

RE: Report No. 3100, v.3  
Your Street  
Anytown, BC  
P0P 0P0

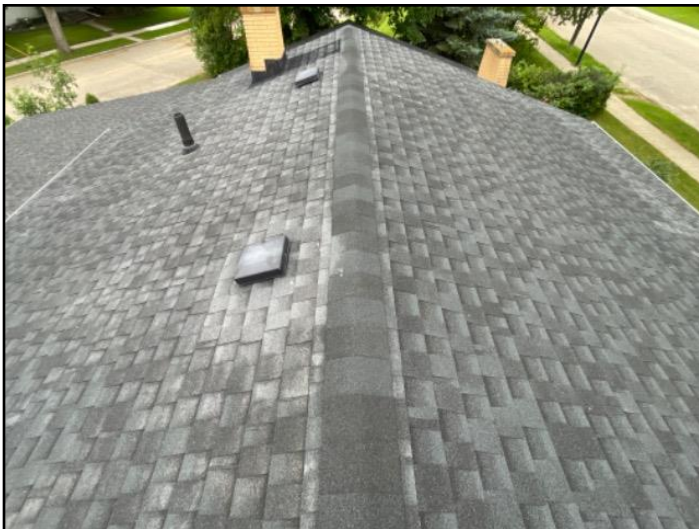
1.

**1. Condition:** • Moss growth and/or debris accumulation observed on the roof surface.

**Implication(s):** Moss and debris can trap moisture, accelerate roof deterioration, impede proper drainage, and may shorten the service life of the roofing system if not addressed.

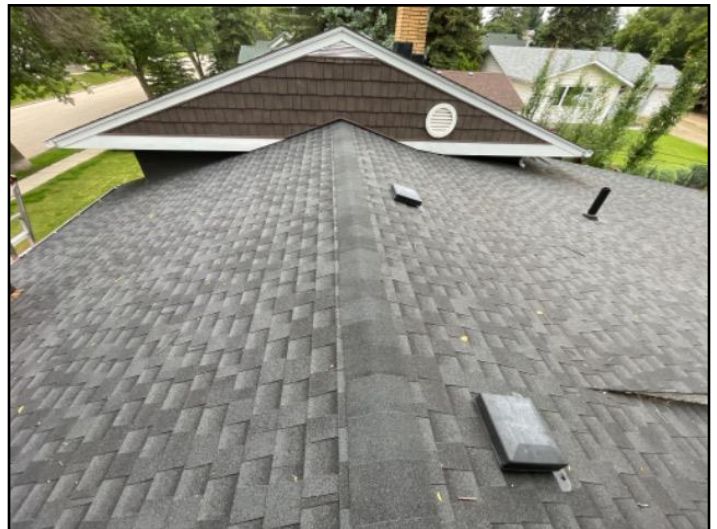
2.

**2. Condition:** • Chimney flashing loose or open seam

**Implication(s):** Loose flashing may allow water intrusion, leading to moisture damage and concealed roof leaks

**Task:** Have the chimney flashing repaired and properly secured by a qualified roofing contractor

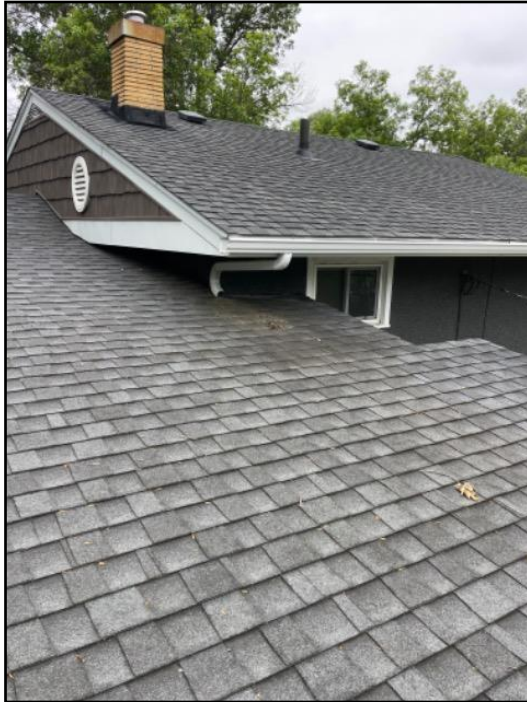
3.

**3. Condition:** • Cricket (roof saddle) missing at chimney

**Implication(s):** Water and debris may accumulate behind the chimney, increasing the risk of roof leaks and roof deterioration

**Task:** Recommend installation of a properly flashed cricket by a qualified roofing contractor

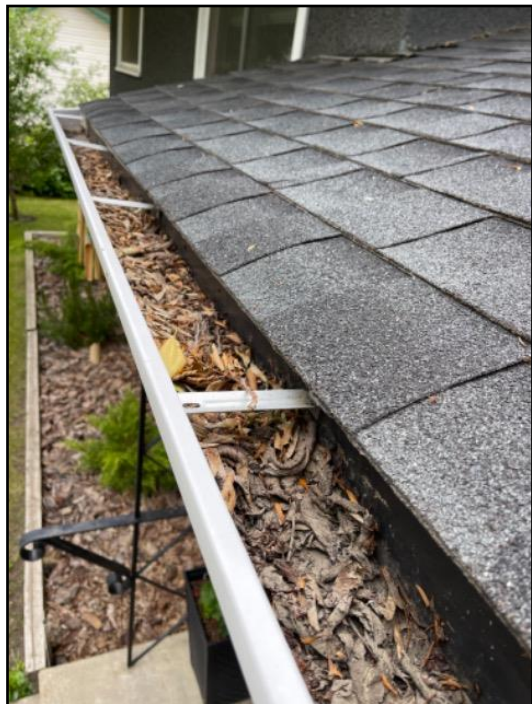
8.

**4. Condition:** • Dirt and debris accumulation observed in the gutters.

**Implication(s):** Accumulated debris observed in gutters. Restricted drainage may cause overflow and moisture-related damage. Clean and maintain gutters as required

**Task:** Recommend cleaning debris from gutter

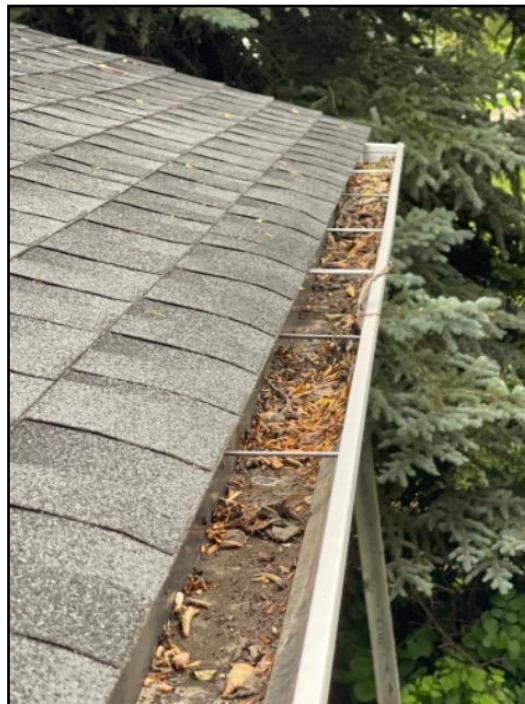
9.

**5. Condition:** • Downspouts discharge onto lower roof surfaces

**Implication(s):** Concentrated water discharge may cause premature roof wear and increase the risk of leaks

**Task:** Recommend extending or redirecting downspouts to an approved drainage location

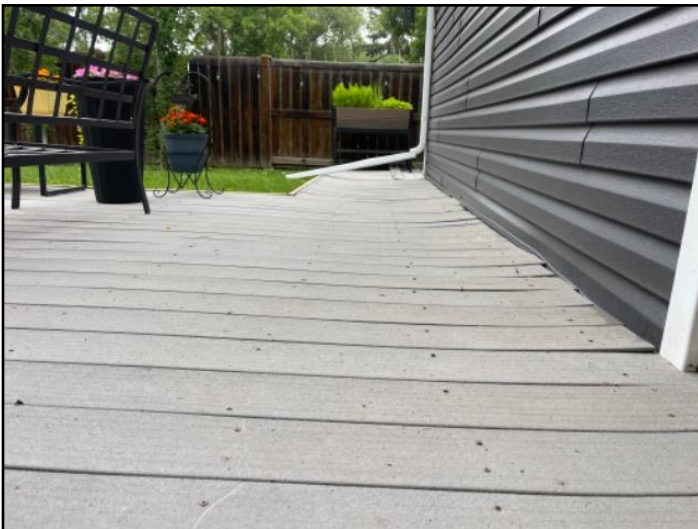
15.

**8. Condition:** • Movement observed at deck floor

**Implication(s):** Deck movement may indicate inadequate support, deterioration, or loose connections, affecting stability and safety

**Task:** Recommend evaluation and repairs by a qualified contractor as needed

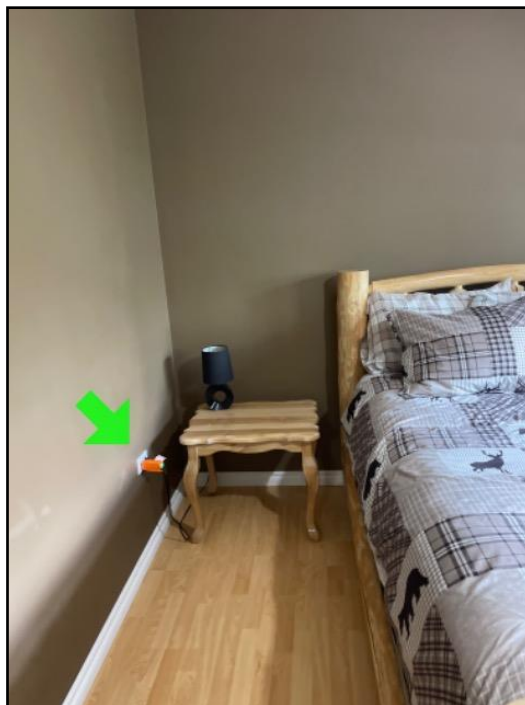
29.

**18. Condition:** • Loose electrical outlet observed

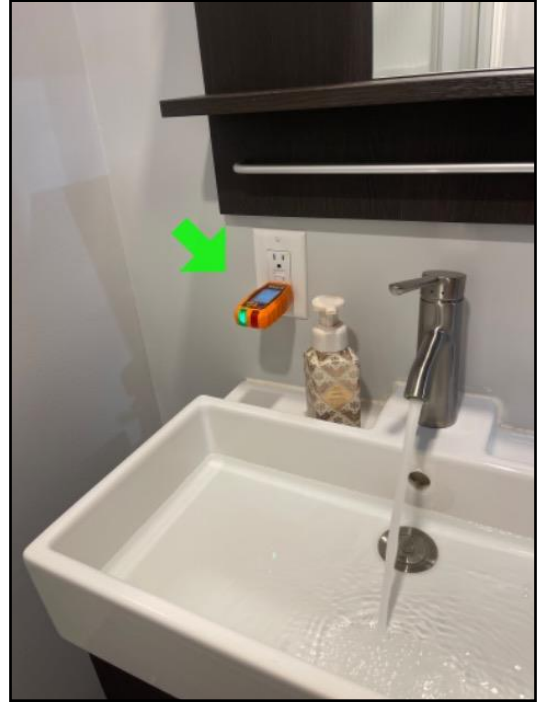
31.

**19. Condition:** • GFCI (Ground Fault Circuit Interrupter) protection not observed
